Manhole Inspection Summary

Manhole # S53M__016MH

Insp Date: **7/21/08 10:00 AM**

Location Address: **928 s ellwood av**

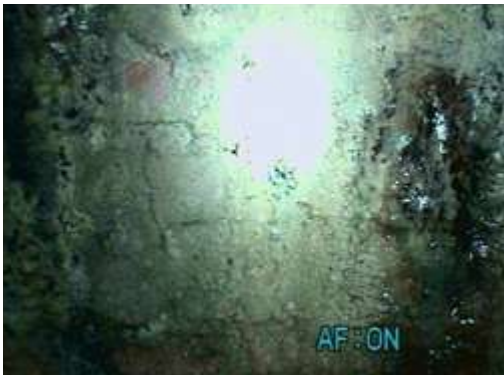
Defect 3

Infiltration: ☐ None ☐ Joint ☐ Cracks ☐ Mortar ☐ Roots ☒ **Wall**

barrel infiltration

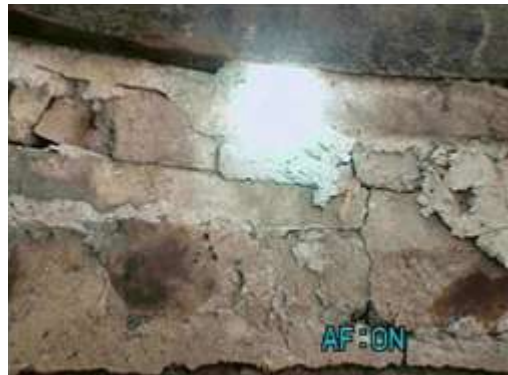
Defect 2

Condition: ☐ Sound ☒ **Cracked** ☐ Root Intrusion ☐ Loose Brick ☐ Deteriorated

cracked, frame adj

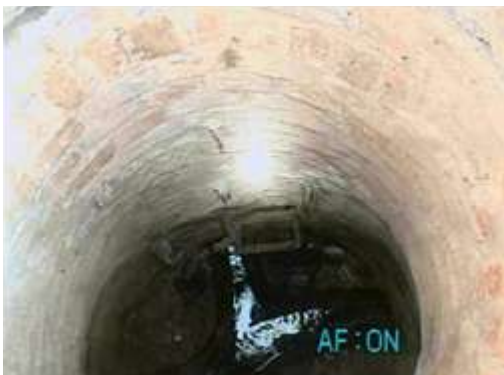
Defect 1

Count: **4** Missing: **3** ☒ **Corroded**

steps missing/corroded
